Manhole Inspection Summary

Manhole # S53I__032MH

Insp Date: **4/11/08 2:04 PM**

Location Address: **rear 516 s. clinton st**

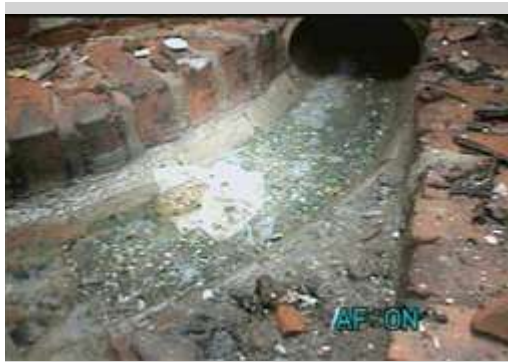
Defect 2

Condition: ☐ Sound ☐ Cracked ☐ Root Intrusion ☐ Deteriorated ☐ Leaks ☒ **Debris**

channel debris

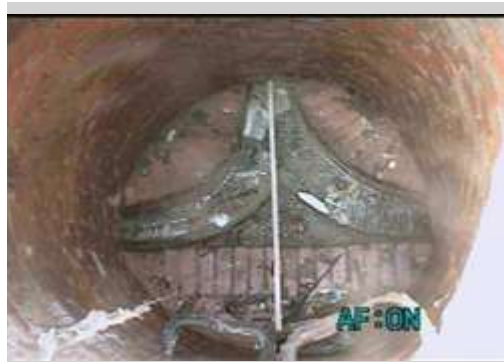
Defect 3

Count: **4** Missing: **0** ☒ **Corroded**

Corroded Steps

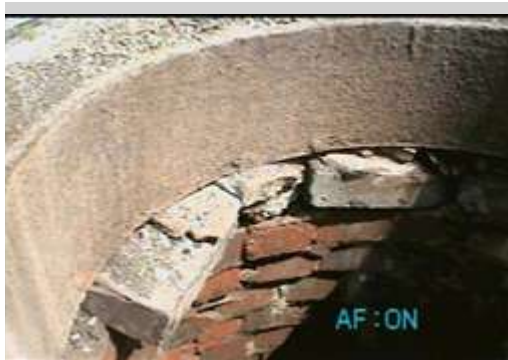
Defect 1

Condition: ☐ Sound ☐ Cracked ☐ Root Intrusion ☒ **Loose Brick** ☐ Deteriorated

chimney loose bricks, frame adjustment

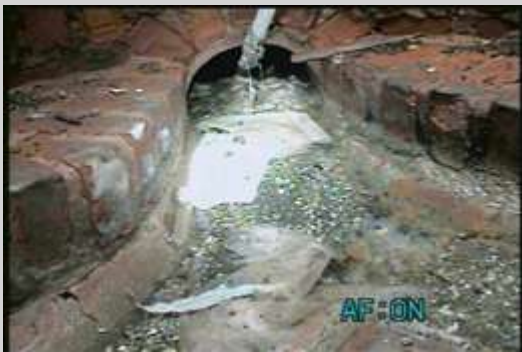
12 O'Clock Outflow

8 in. Circular Gravity Sewer
Pipe Out @ 12 O'Clock

Deposits: ☐ None ☐ Mud ☒ Sludge ☒ Debris ☐ Grease

Silt Depth: **3** (in.) Deposits Extent: **Medium**
